Aztec Property Inspections
3655 Cowley Way
San Diego, CA 92117
(661) 858-4486

1234 City St
Kern County, CA 93561

Jan Jackson
Sample Report

Property Information

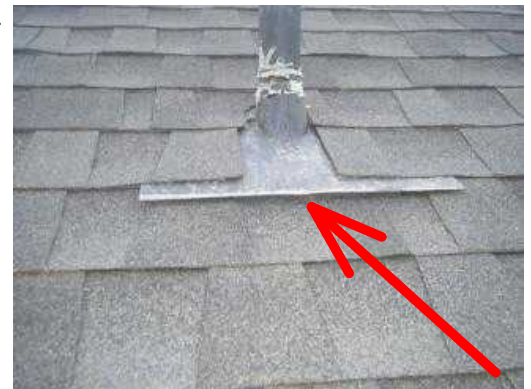
Acceptable **Material:** (Asphalt composite shingle) Debris noted on roof. Removal is recommended.

Acceptable **Flashing:** Loose flashing was noted in one or more areas. Correction is recommended.

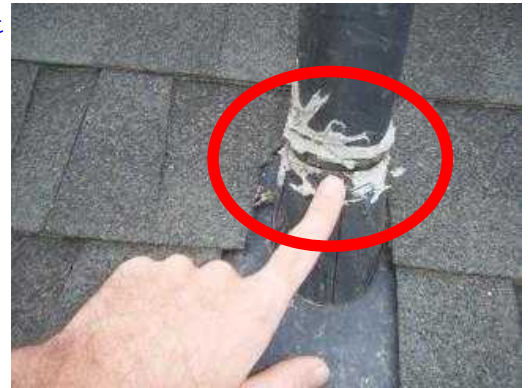
Plumbing Vents: Mastic is needed around vent pipes to ensure the water tightness of the roofing system.

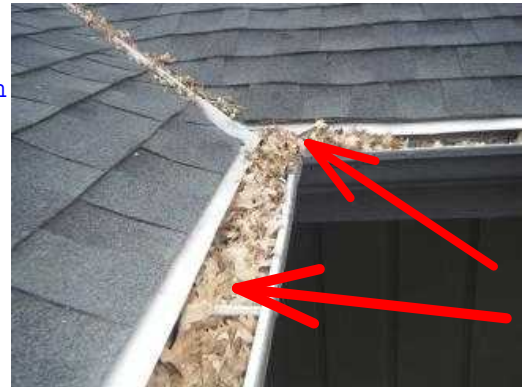
Downspouts: Add splash blocks for improved drainage. Rout away in one or more areas. Correction is recommended.

Gutters: Recommend adding full gutters for improved drainage. Debris filled gutters were noted in one or more areas. Correction is recommended.

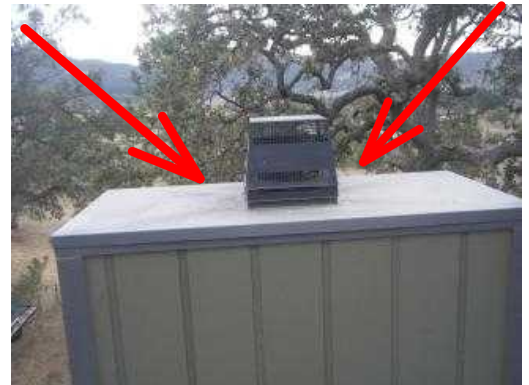
Flue/Flue Cap: The chimney crown does not slope outwards properly to shed water. Correction is recommended.

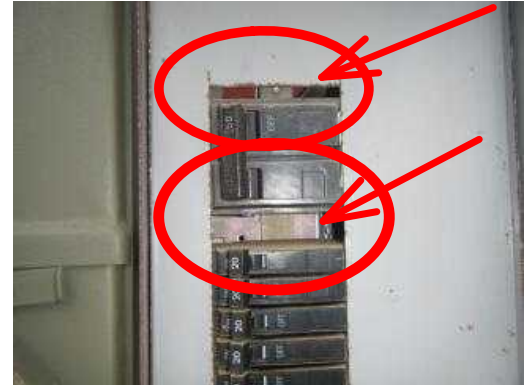
Safety Upgrade, Marginal **Condition:** Open gaps and or knock outs were noted in one or more areas which are exposing hot wires. Recommend sealing these areas for added safety.

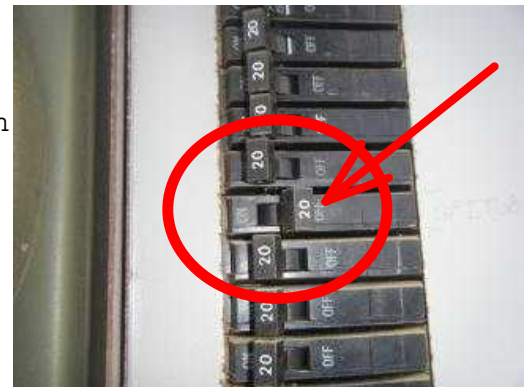
Breakers: (Copper) One or more breakers were not labeled. Correction is recommended. One or more breakers were off at the time of the inspection. Inquire with the seller as to why.

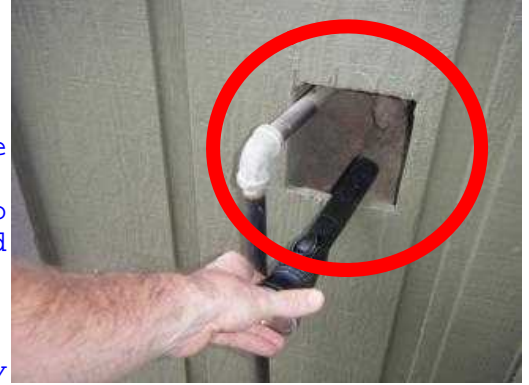
Exterior Walls: Gaps or holes not properly sealed at several areas. This can lead to moisture penetration and damage. This can also be used as a conduit for insects to enter the house. Common cracks noted in one or more areas. In some areas the wood siding does not have the proper distance to the patio, soil and or walkways. This could cause damaged wood and create a moisture intrusion problem. Damaged, soft and or deteriorated wood was noted in one or more areas. Further evaluation is recommended by a qualified and licensed pest control specialist.

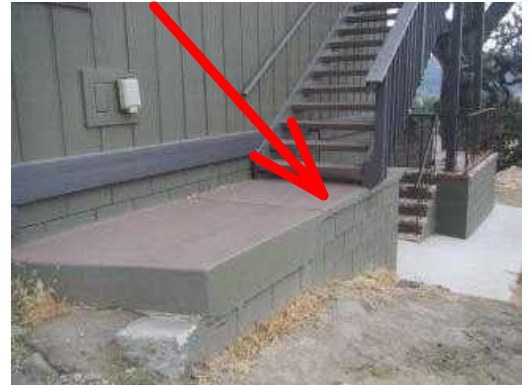
Walkways: A walk off or drop off hazard noted in one or more areas. Recommend installing guard rails for added safety.

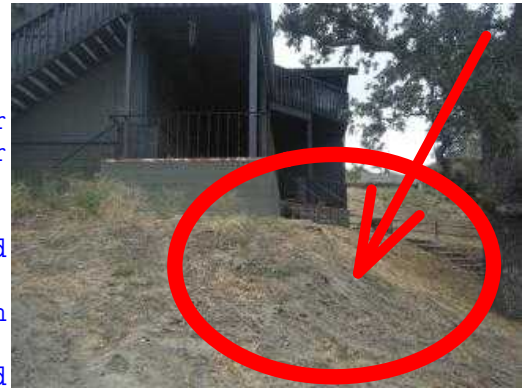
Grading: The perimeter grading does not slope down and away from the structure in one or more areas. No drainage was visible in one or more areas. This could trap water near the structure. Inquire with the seller to verify that drainage has been installed that is not visible or underground. Wet soil may cause the foundation to settle and possibly fail over time. Recommend having all soil and or hardscape so it slopes down and away from the structure properly or adding drainage as necessary using standard building practices. Soil in one or more areas was not supported. This may be acceptable if the soil/rock is deemed as stable enough by a licensed professional. Determining this is beyond the scope of this inspection. Further evaluation is recommended.

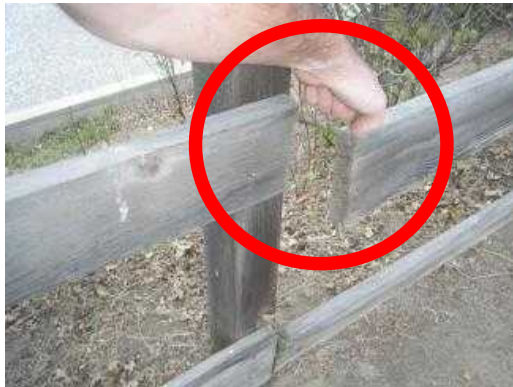
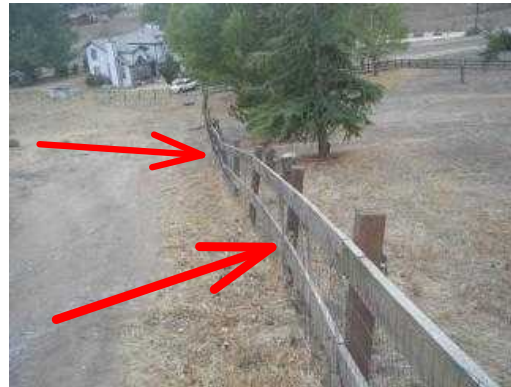
Fences: Damage and deterioration was noted in one or more areas. Loose and or leaning fencing was noted in one or more areas. Unfinished wood was noted in one or more areas. Stain and or finish is recommended.

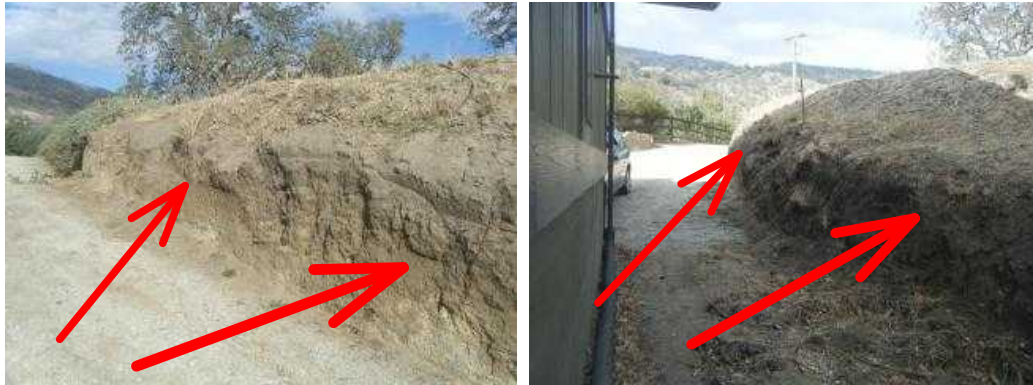
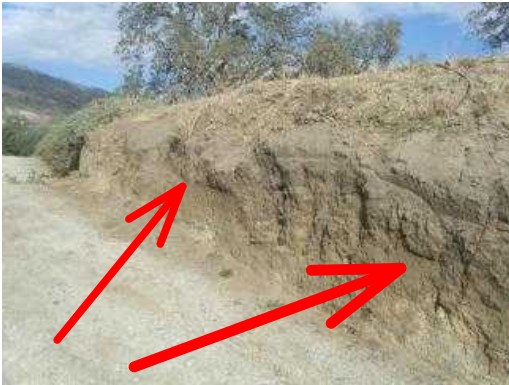
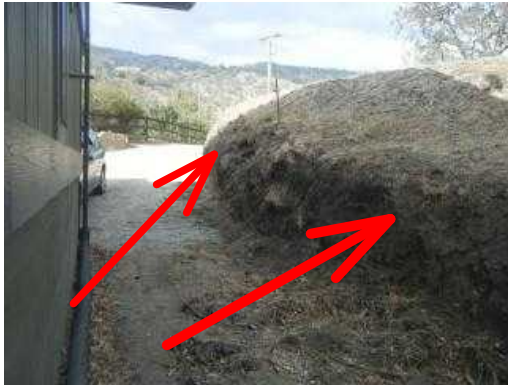
Retaining Walls: Soil has given way and or eroded in one or more areas. Soil in one or more areas was not supported. This may be acceptable if the soil/rock is deemed as stable enough by a licensed professional. Determining this is beyond the scope of this inspection. Further evaluation by a licensed contractor is recommended.

- 1. Retaining Walls:** Soil has given way and or eroded in one or more areas. Soil in one or more areas was not supported. This may be acceptable if the soil/rock is deemed as stable enough by a licensed professional. Determining this is beyond the scope of this inspection. Further evaluation by a licensed contractor is recommended.

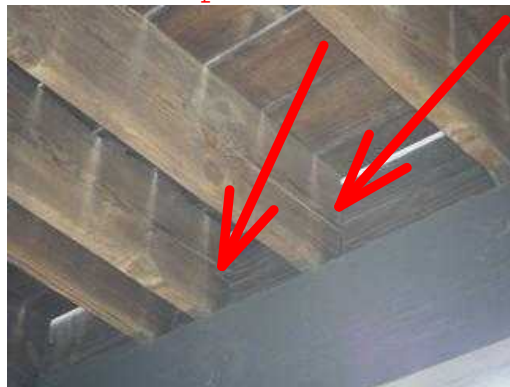
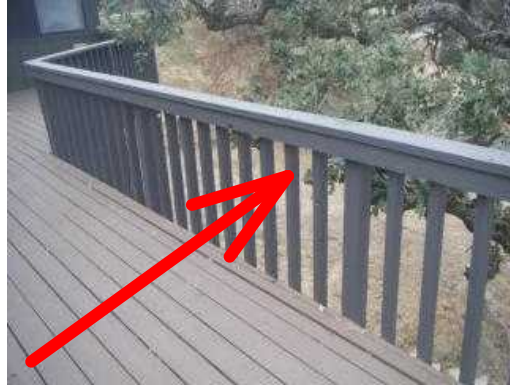
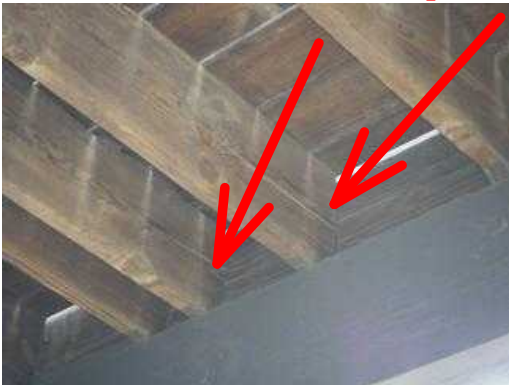
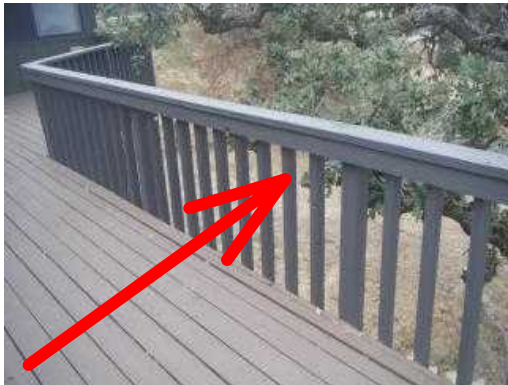
Deck: Framing straps were missing in one or more areas. Loose handrails and or guardrails were noted in one or more areas. A qualified contractor is recommended to evaluate and estimate repairs.

- 2. Deck:** Framing straps were missing in one or more areas. Loose handrails and or guardrails were noted in one or more areas. A qualified contractor is recommended to evaluate and estimate repairs.

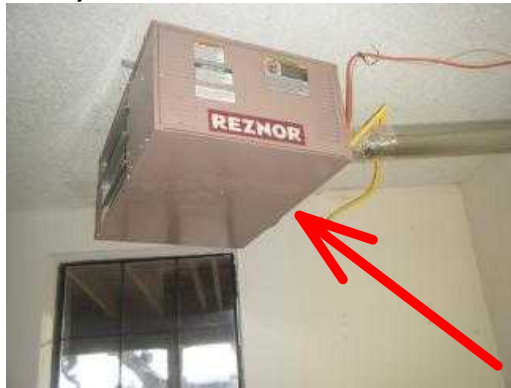
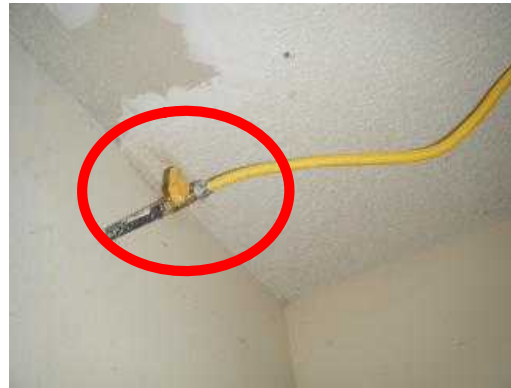
Operation: The local utility company is recommended for a complimentary safety inspection before the close of the contingency period. The pilot was not lit and or the gas was off to the unit. Unable to inspect.

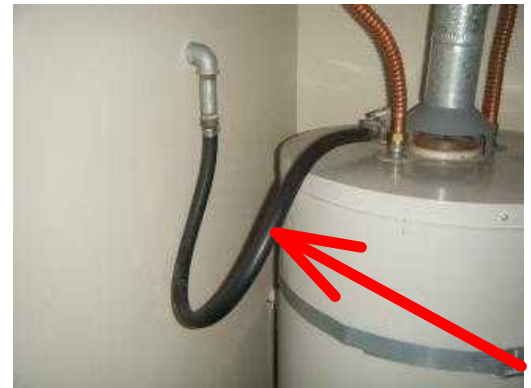
Acceptable **Flue Pipe:** Not fully visible. The draft diverter was not properly secured. Correction is recommended.

Acceptable, Safety Upgrade **TPR Valve and Drain :** Improper material noted (flexible). The slope was improper at one or more areas. Correction is recommended.

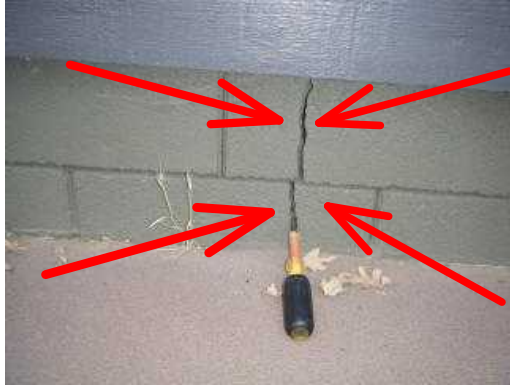
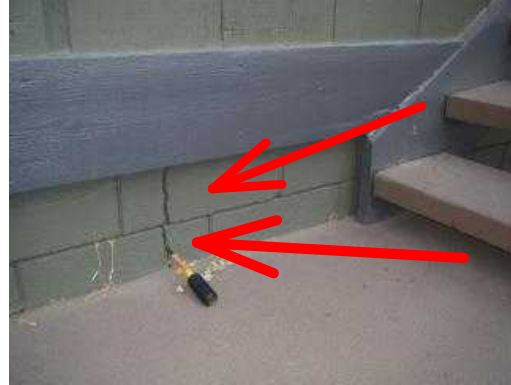
Marginal **Floor/Slab:** Slab was not visible due to carpet and/or floor covering. The exterior portion of the slab has been painted and or covered with stucco and was not fully visible. Cracks were seen in the slab. Home inspectors are generalists and as so, it is beyond the expertise of the inspector to determine the significance of these items. The client may wish to consult with a civil engineer to determine the significance of the cracks.

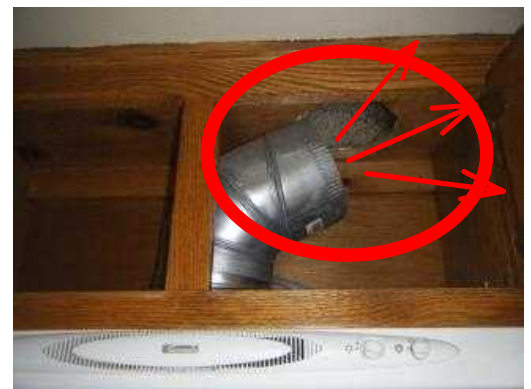
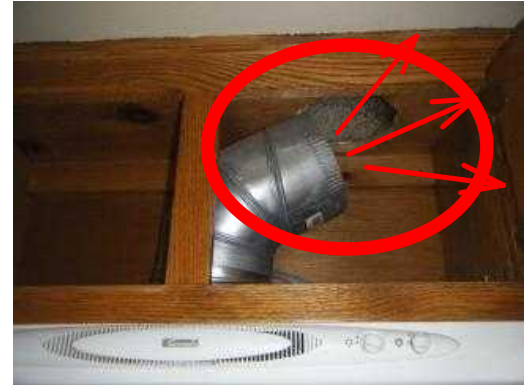
Ventilator: The vent was disconnected and was blowing air into the cabinet. A qualified contractor is recommended to evaluate and estimate repairs.

3. **Kitchen Ventilator:** The vent was disconnected and was blowing air into the cabinet. A qualified contractor is recommended to evaluate and estimate repairs.

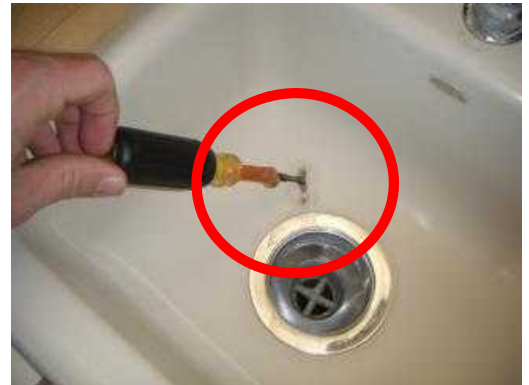
Sink: Damage noted to the sink (island sink). Correction is recommended.

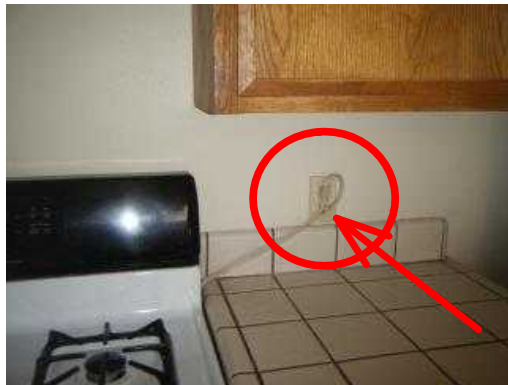
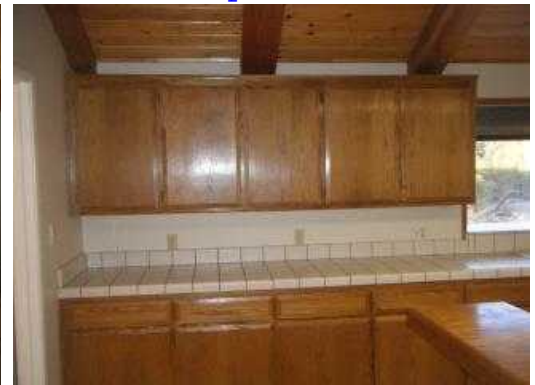
Electrical: Non-GFCI circuit noted. Recommend GFCI circuit be installed for added safety. No dedicated electrical outlet has been installed for the range. The under cabinet lights made an unusually loud buzzing noise. A qualified licensed contractor is recommended to evaluate and estimate repairs.

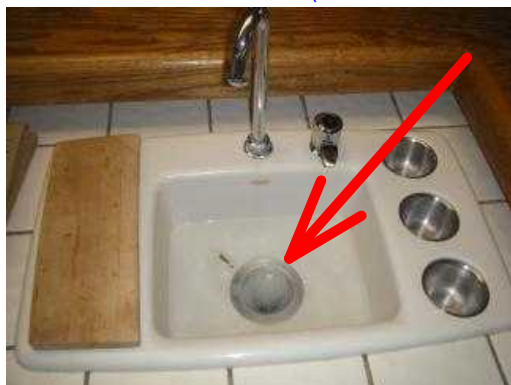
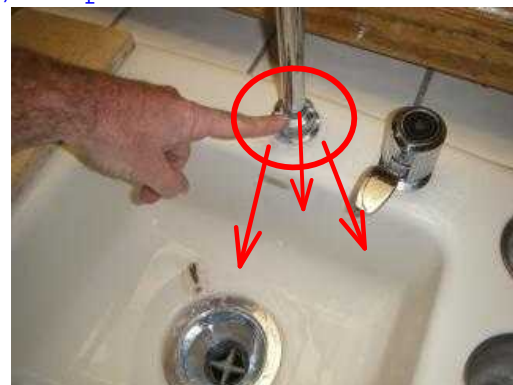
Plumbing/Fixtures: A slow drain was noted (island sink). A leak was noted from the fixture (island sink). Replacement is recommended.

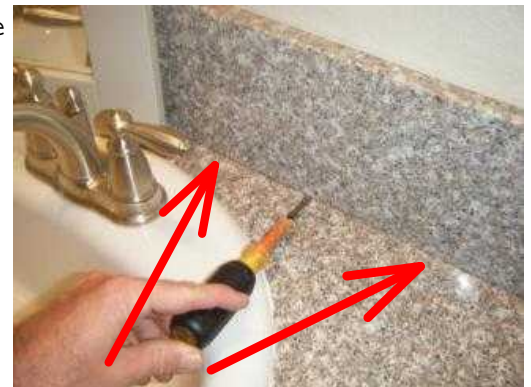
Counter/Cabinet: Caulk is recommended at the back splash.

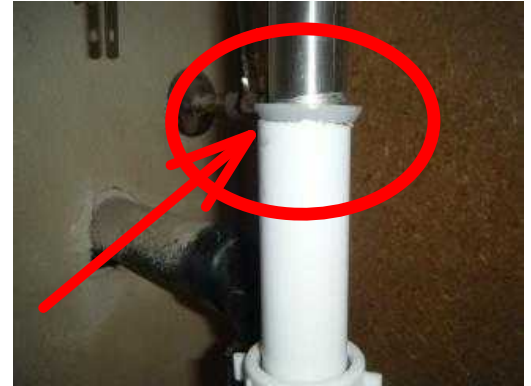
Faucets/Traps: Improper drain installation was noted. A licensed plumber is recommended to estimate repairs.

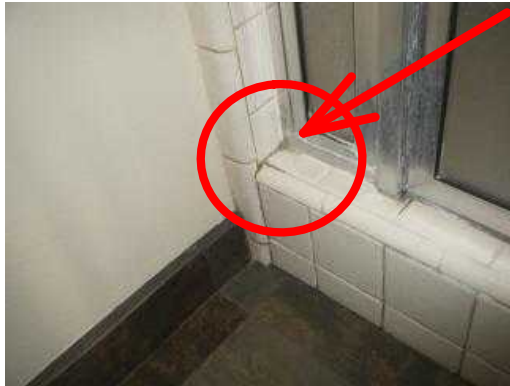
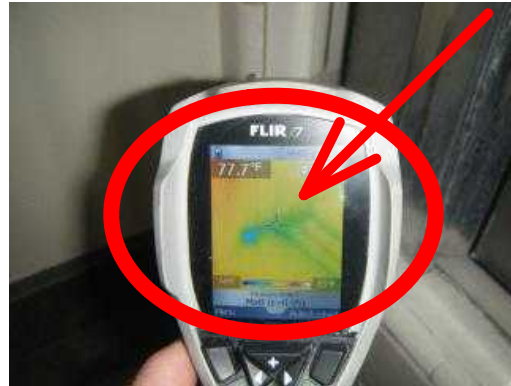
Shower/Surround: Grout is cracked in one or more locations. Correction is recommended. Shower enclosure showed evidence of leakage and needs caulk and or weather strip in one or more areas.

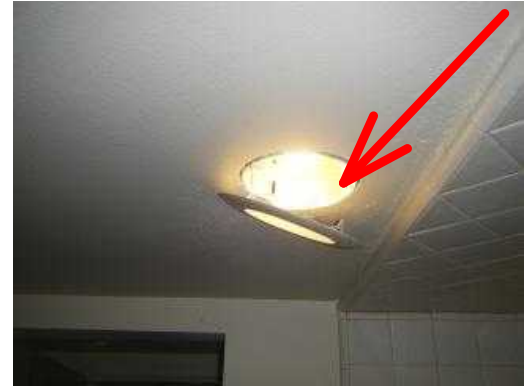
Electrical: (120 GFCI) Light covers were loose at one or more areas. Correction is recommended.

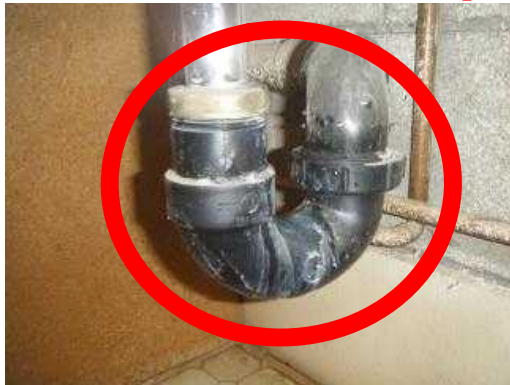
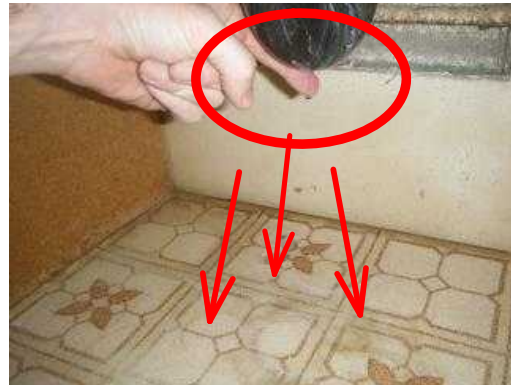
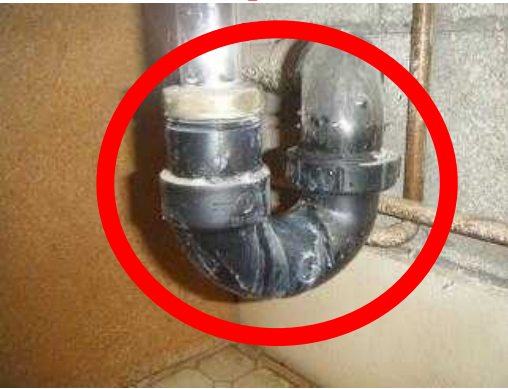
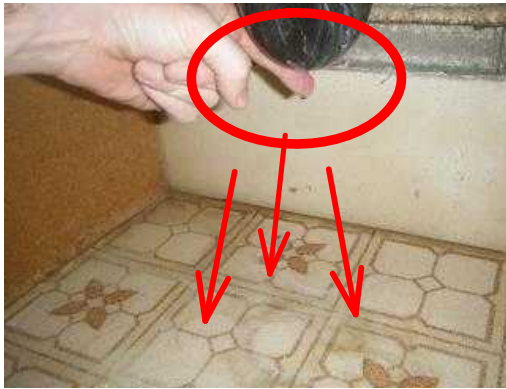
Faucets/Traps: The fixture can spray water outside the sink. A slow drain was noted. A leak was noted from the drain. A licensed plumber is recommended to estimate repairs.

4. **Lower Bathroom Faucets/Traps:** The fixture can spray water outside the sink. A slow drain was noted. A leak was noted from the drain. A licensed plumber is recommended to estimate repairs.

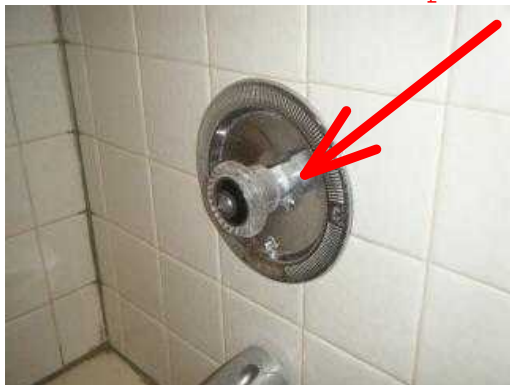
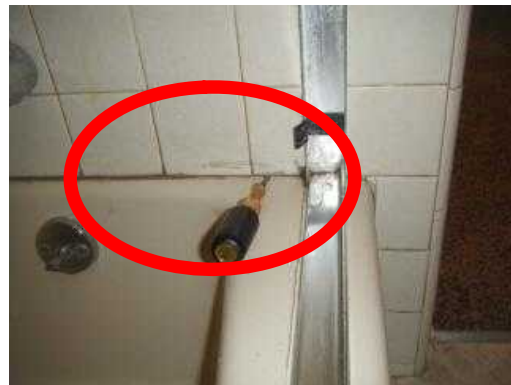
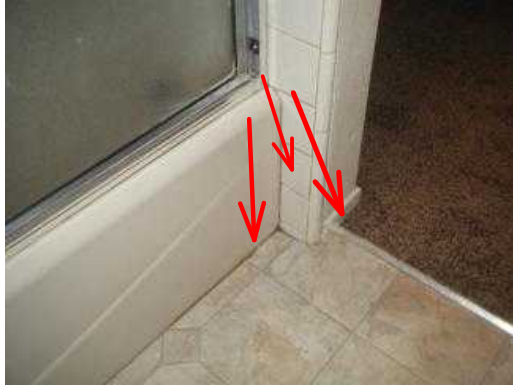
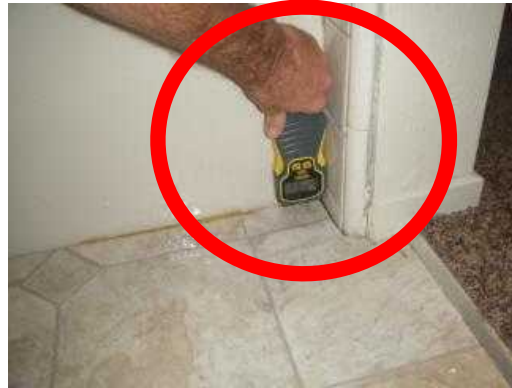
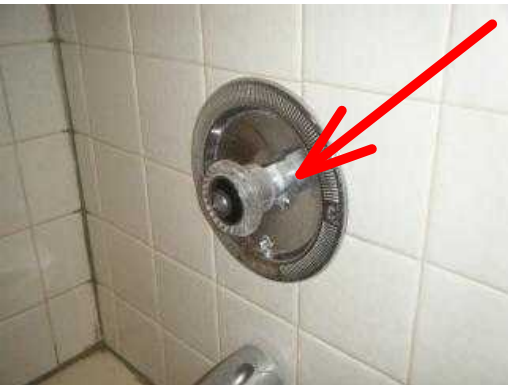
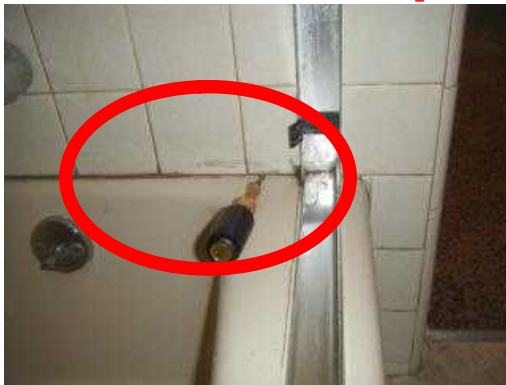
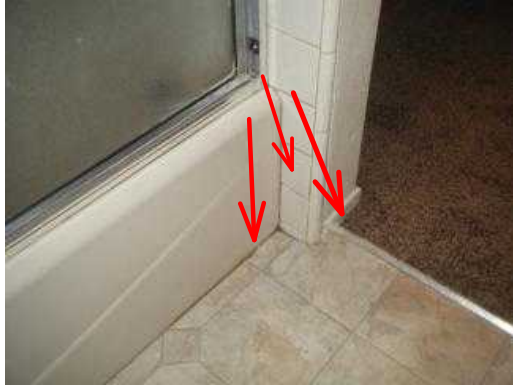
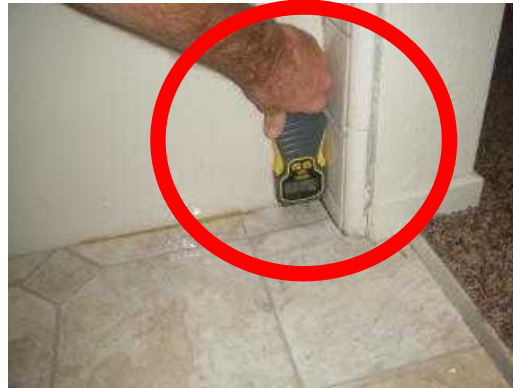
Tub/Surround: Difficult to operate fixture noted (cartridge may need replacement). Tub diverter was not properly functional. The unit was stuck in one mode. Caulk is needed at the tub to wall connection. Evidence of moisture intrusion noted on the walls directly outside of the tub enclosure. A qualified licensed contractor is recommended to evaluate and estimate repairs.

5. **Lower Bathroom Tub/Surround:** Difficult to operate fixture noted (cartridge may need replacement). Tub diverter was not properly functional. The unit was stuck in one mode. Caulk is needed at the tub to wall connection. Evidence of moisture intrusion noted on the walls directly outside of the tub enclosure. A qualified licensed contractor is recommended to evaluate and estimate repairs.

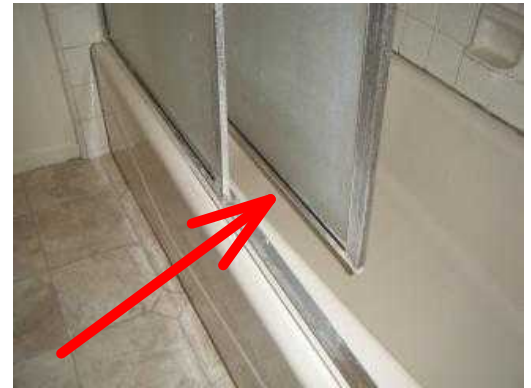
Shower/Surround: Gaps were noted which need to be sealed around the fixtures. Caulking all penetrations is highly recommended. Shower enclosure doors were not on the bottom track. Correction is recommended for added safety.

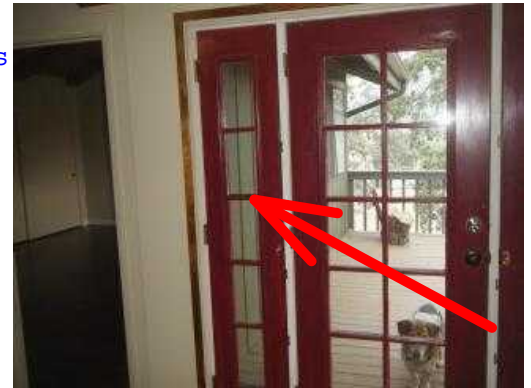
Exterior Door(s): One or more sidelights were stuck in the closed position. Correction is recommended.

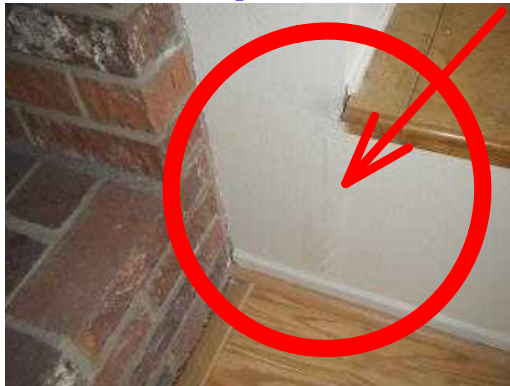
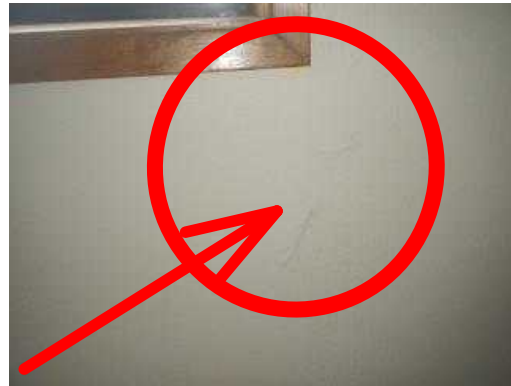
Walls: "Running" was noted to the paint in one or more areas (family room near fireplace, master bedroom near window). This is typically due to moisture. No moisture was noted during the inspection. Further evaluation may be desired.

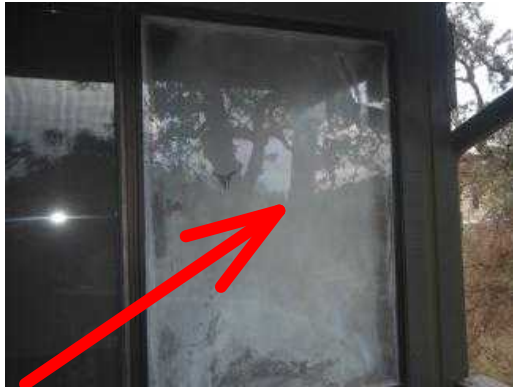
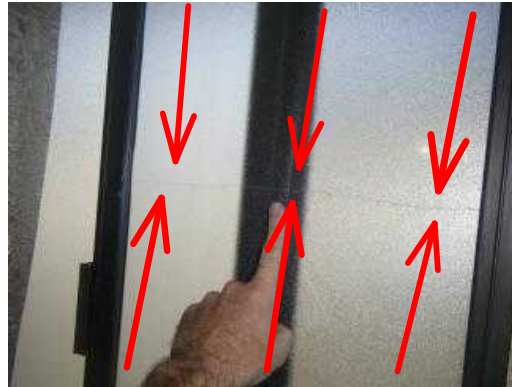
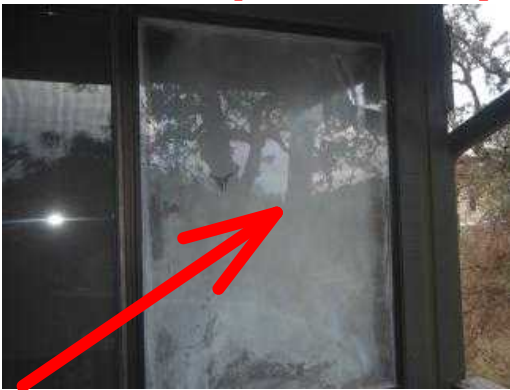
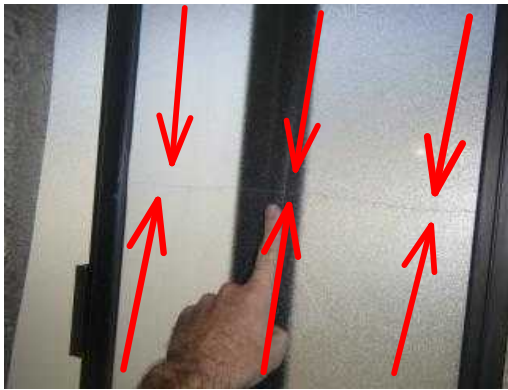
Windows: Moisture and or discoloration was noted to one or more windows between the glass panes. This is usually due to a damaged seal. Broken and or damaged glass noted in one or more areas (master bathroom). Further evaluation is recommended by a licensed specialist.

6. **Living Space Windows:** Moisture and or discoloration was noted to one or more windows between the glass panes. This is usually due to a damaged seal. Broken and or damaged glass noted in one or more areas (master bathroom). Further evaluation is recommended by a licensed specialist.

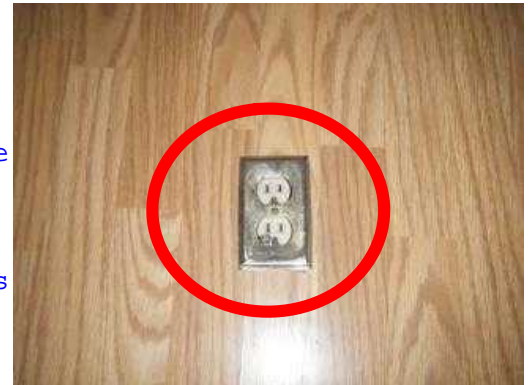
Electrical: Improper floor outlet was noted at one or more locations. Damaged outlet noted at one or more locations. Replacement is recommended. Three outlets were wired to the switch in the upper and lower bedrooms. Unable to verify switch able light source in one or more rooms (master bedroom). A qualified licensed contractor is recommended to evaluate and estimate repairs.

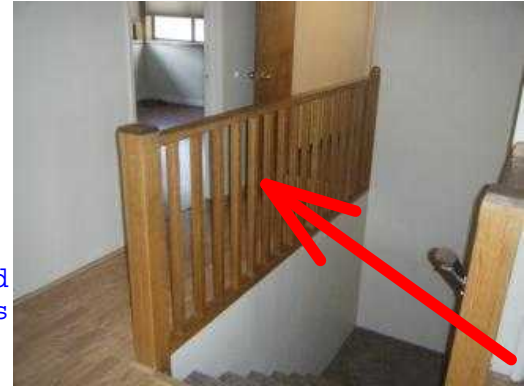
Stairs and Railings: Loose guardrails were noted in one or more areas. Handrails were improper in one or more areas. The current building practice is that they should tie back into the wall for added safety. Slats of the guardrail and or handrail have gaps that are too wide based on the current standards. This is designed to protect infants and small children from falling through. Correction is recommended for added safety.

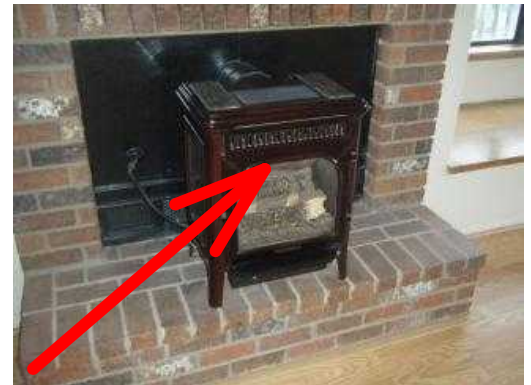
Fireplace Construction: (Metal Free Standing)
The pilot was not lit and or the gas was off to the unit. Unable to inspect.

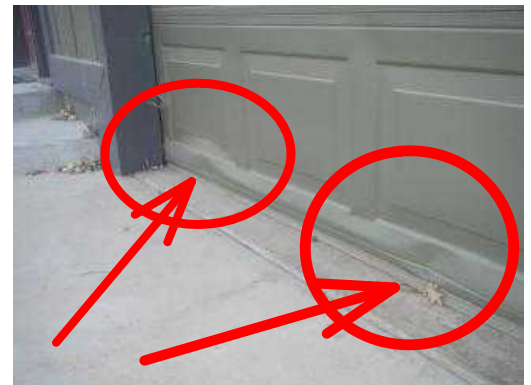
Marginal **Vehicle Door(s) and Operation:** Dents noted to door. Correction is recommended.

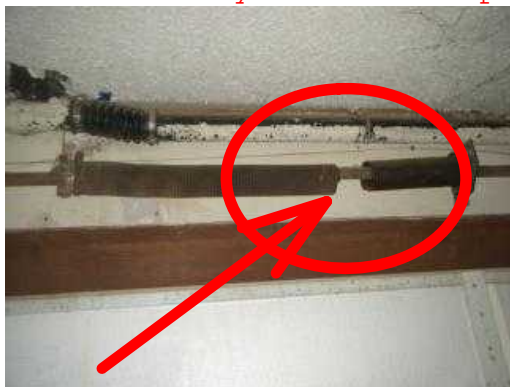
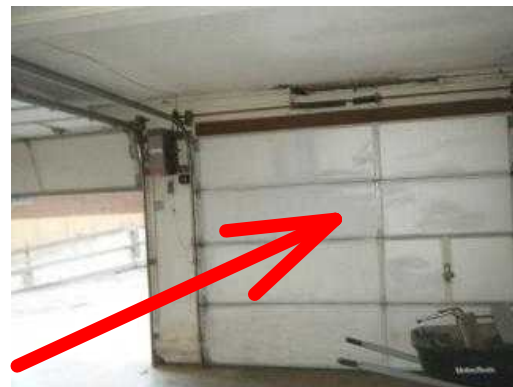
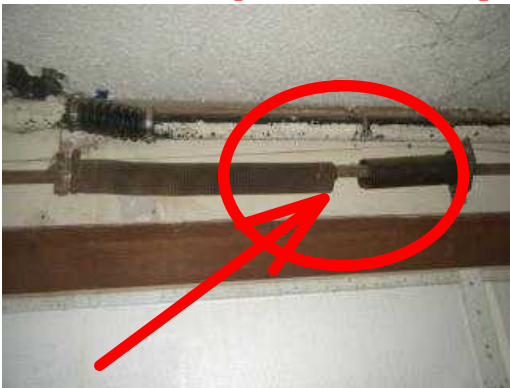
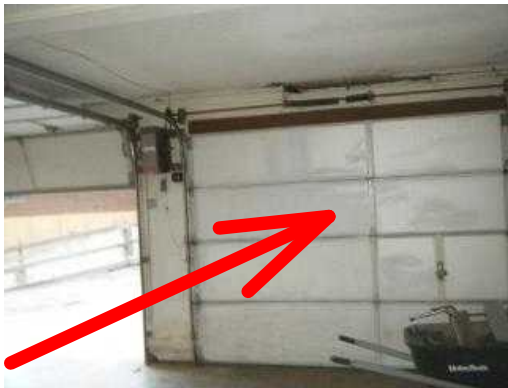
Electric Opener: Inoperative at time of inspection. Further evaluation is recommended by a licensed specialist.

7. **Garage Electric Opener:** Inoperative at time of inspection. Further evaluation is recommended by a licensed specialist.

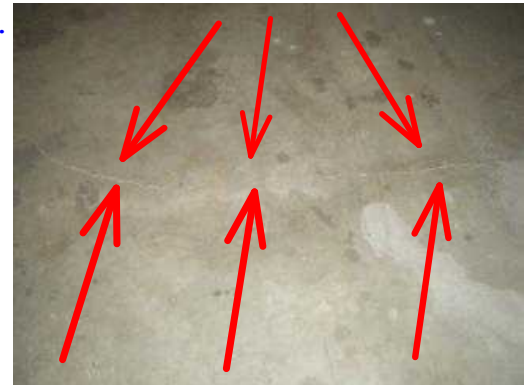
Marginal **Floor/Foundation:** Moderate cracks were noted. Correction is recommended.
